1427 Ellis Woods Loop  
Sevierville TN 37876

3/8/2017

*Limited Element Inspection - Roof*

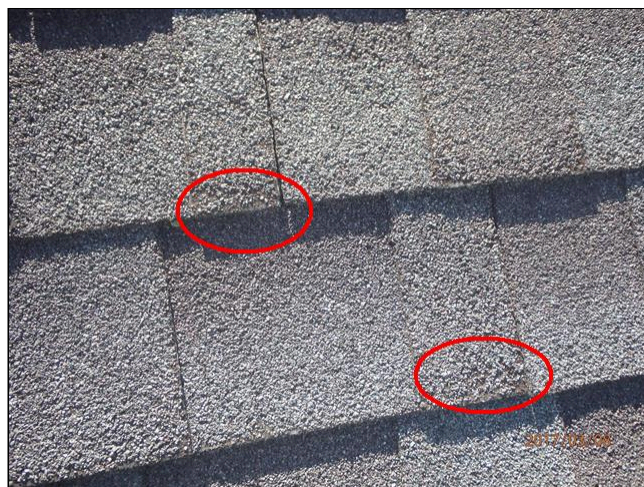
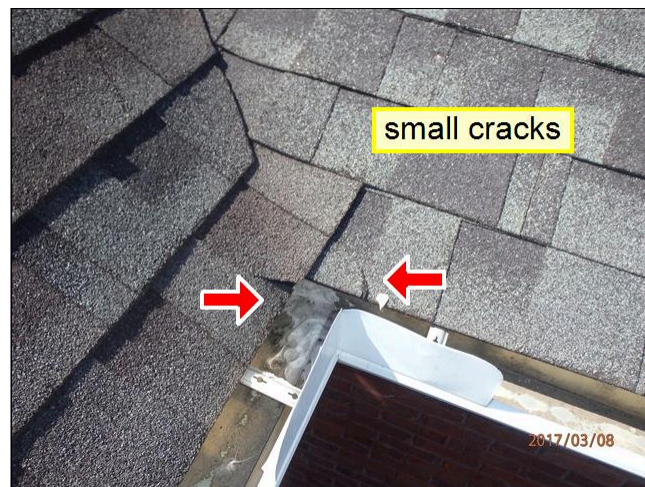
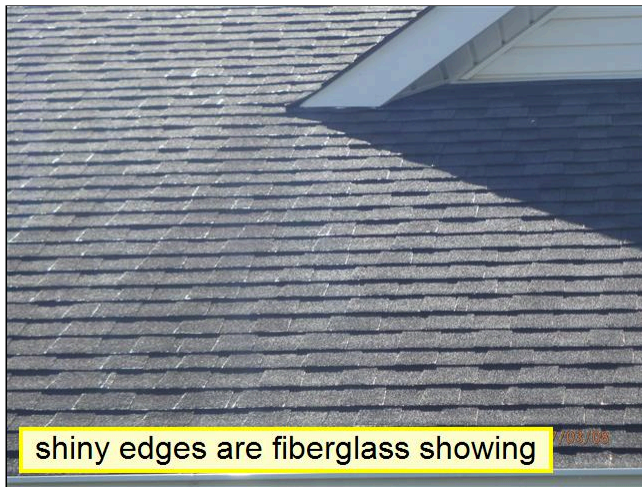
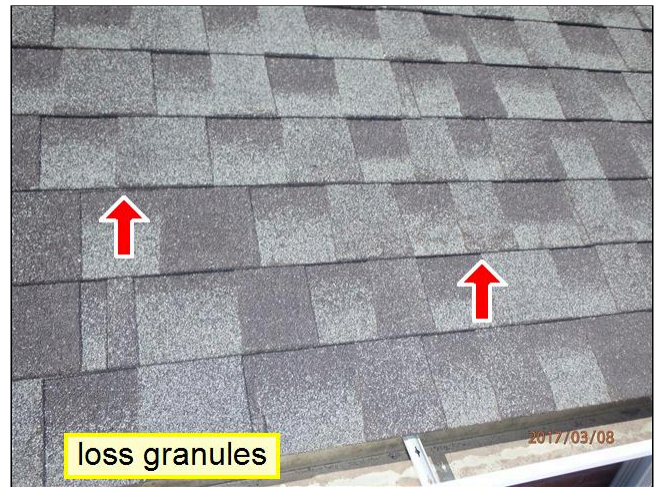
1.0 ROOF COVERING (.1) Item 1(Picture)

1.0 ROOF COVERING (.1) Item 2(Picture)

1.0 ROOF COVERING (.1) Item 3(Picture)

1.0 ROOF COVERING (.1) Item 4(Picture)

Roof is showing an unusual loss of granules for its age. Loss such that some of the fiberglass mesh is beginning to show. Some small cracking of shingles also seen. Although these conditions are indicators that roof is nearing end of life, I think it has a few more years left (less than 5 years). Recommend budgeting and planning for replacement. Monitor shingles for further deterioration - large cracks, nail holes, nearly total granule loss, and broken shingles.

No indicators of leaks found such as staining of sheathing in attic or stains on ceilings in interior.

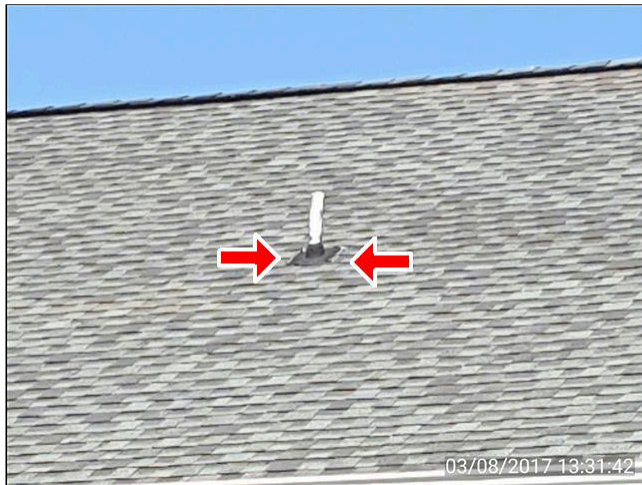
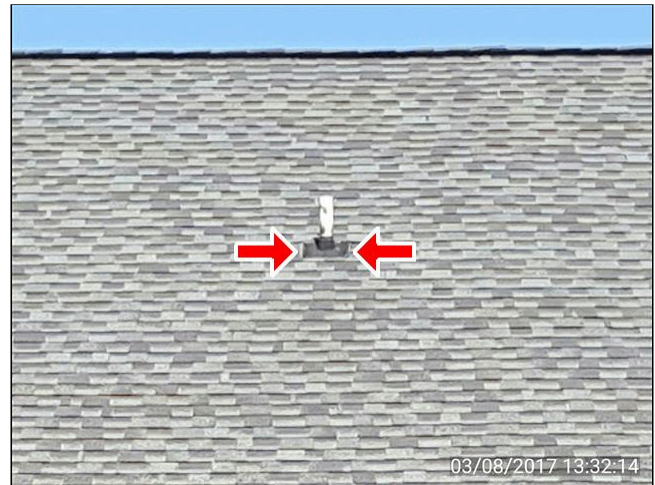
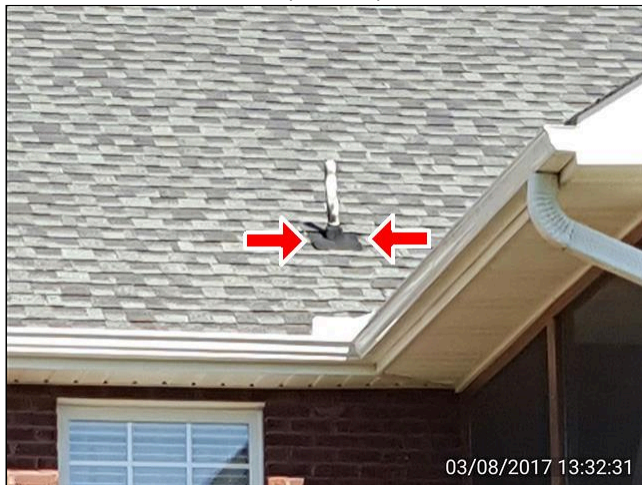
1.2 PLUMBING/ELECTRICAL STACKS (.1) Item 1(Picture)

1.2 PLUMBING/ELECTRICAL STACKS (.1) Item 2(Picture)

1.2 PLUMBING/ELECTRICAL STACKS (.1) Item 3(Picture)

Boots for plumbing, vents, electrical stacks and flues should have shingles that are lapped over boot on top and sides. Sides are not lapped. Recommend having roofing expert seal the sides of boot.

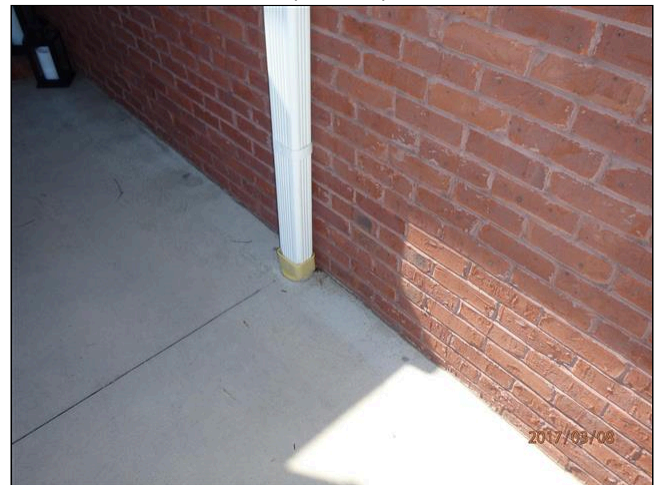
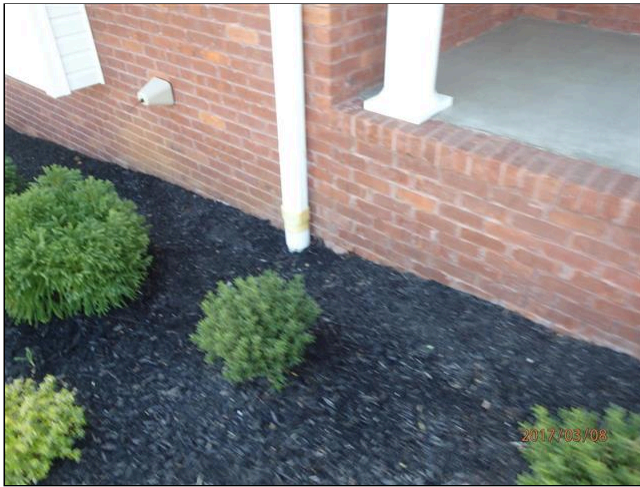
1.5 DOWNSPOUTS / ROOF DRAINS (.1) Item 1(Picture)

1.5 DOWNSPOUTS / ROOF DRAINS (.1) Item  
2(Picture)

Downspouts that run into the ground are subject to backup/blockage. Neither the presence nor integrity of underground lines, nor free flow of water through such lines is determinable as part of this inspection. I would recommend finding the end of these drain lines to make sure they are not clogged.

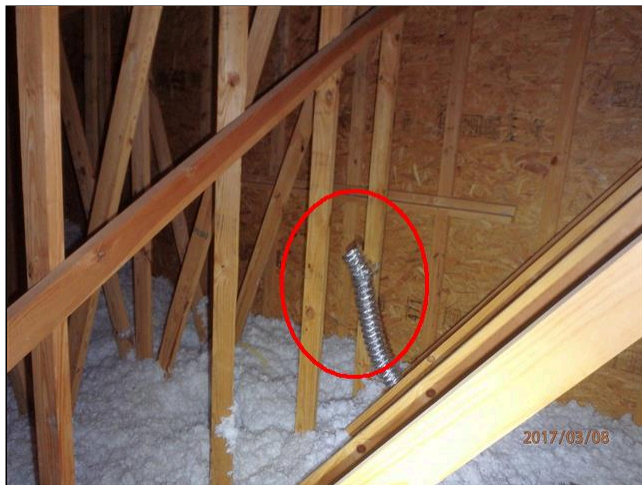
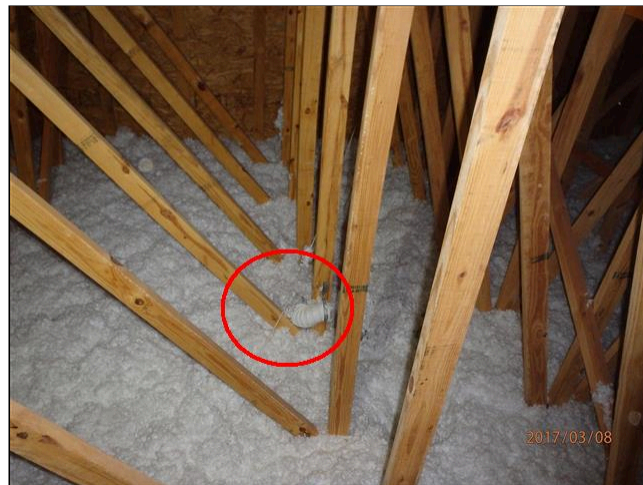
2.4 VENTILATOR DISCHARGE (.1) Item 1(Picture)

2.4 VENTILATOR DISCHARGE (.1) Item 2(Picture)

Bathroom ventilators discharge into the attic. This puts more moisture into an attic and may cause mold to grow. Recommend having ventilator discharge to outside.
