1427 Ellis Woods Loop
Sevierville TN 37876

3/8/2017

J & S Home Services, Inc. dba HouseMaster

Limited Element Inspection - Roof

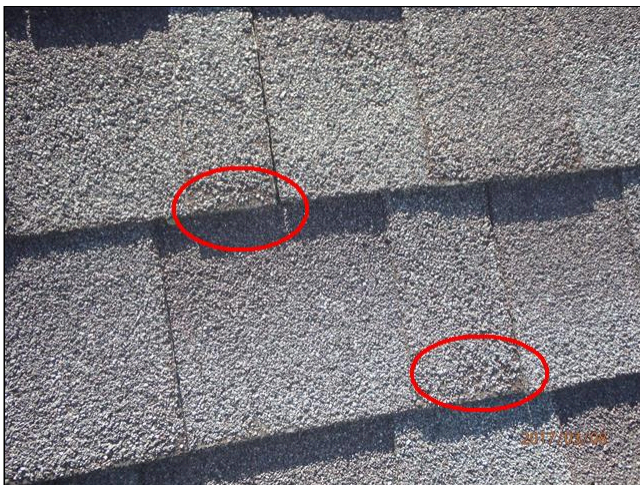
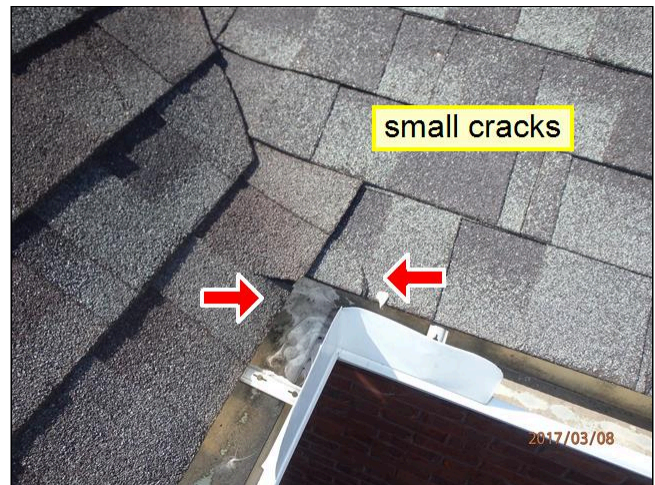
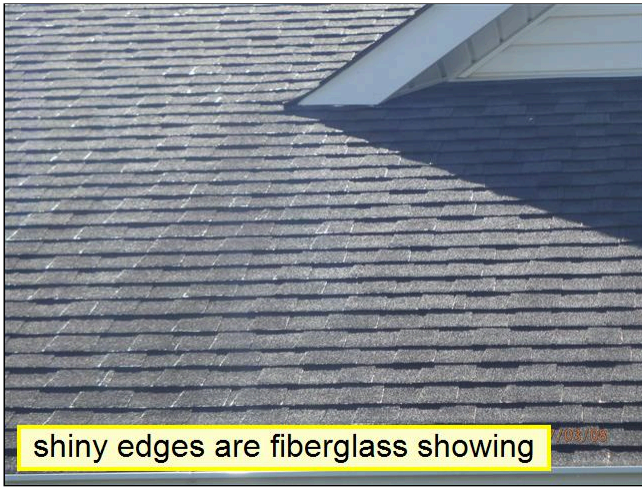
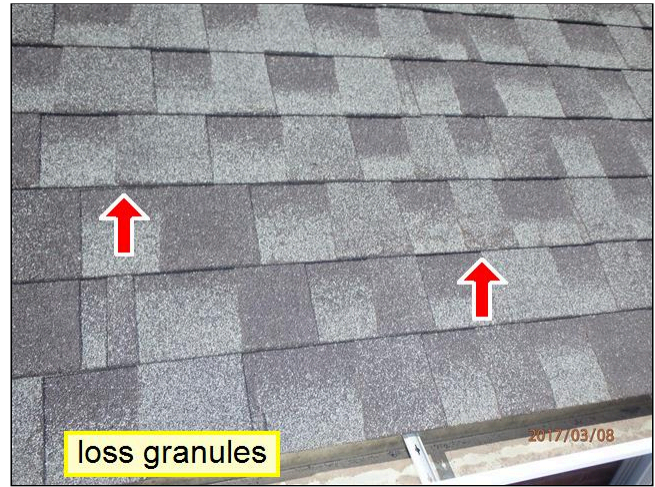
1.0 ROOF COVERING (.1) Item 1(Picture)

1.0 ROOF COVERING (.1) Item 2(Picture)

1.0 ROOF COVERING (.1) Item 3(Picture)

1.0 ROOF COVERING (.1) Item 4(Picture)

Roof is showing an unusual loss of granules for its age. Loss such that some of the fiberglass mesh is beginning to show. Some small cracking of shingles also seen. Although these conditions are indicators that roof is nearing end of life, I think it has a few more years left (less than 5 years). Recommend budgeting and planning for replacement. Monitor shingles for further deterioration - large cracks, nail holes, nearly total granule loss, and broken shingles.

No indicators of leaks found such as staining of sheathing in attic or stains on ceilings in interior.

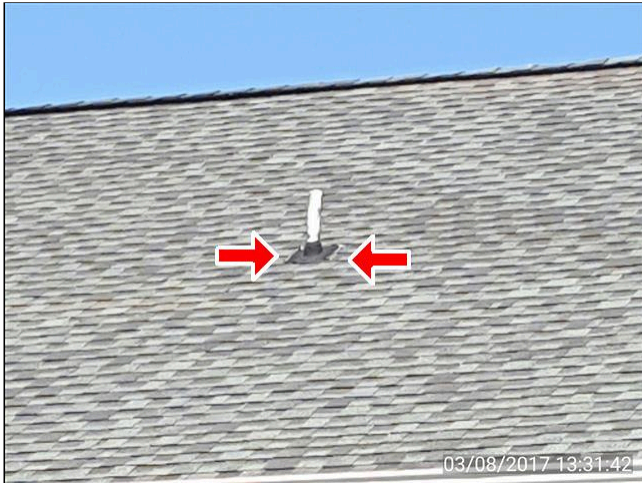
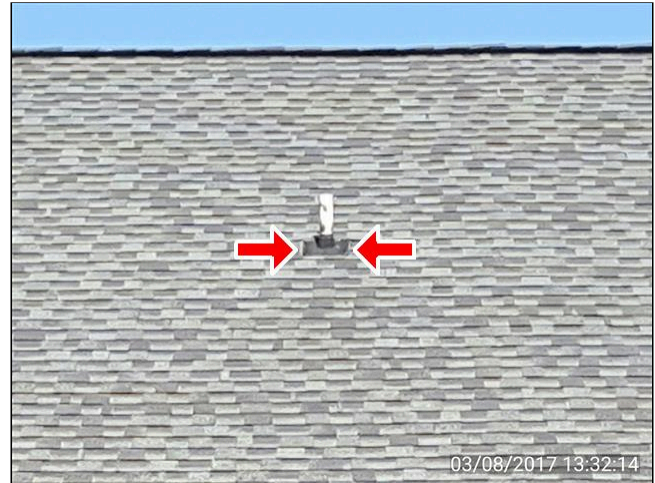
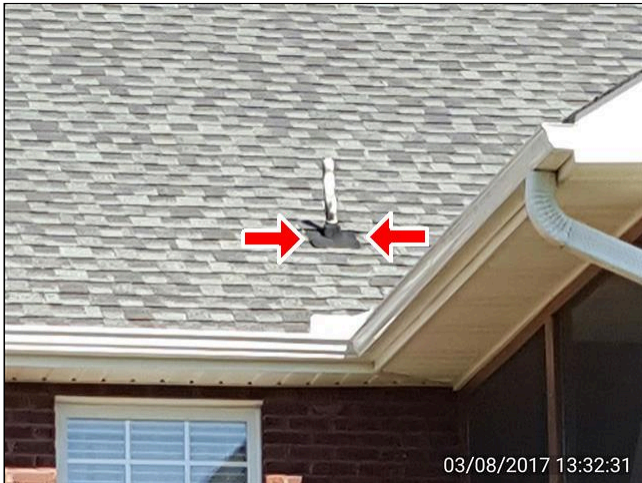
1.2 PLUMBING/ELECTRICAL STACKS (.1) Item 1(Picture)

1.2 PLUMBING/ELECTRICAL STACKS (.1) Item 2(Picture)

1.2 PLUMBING/ELECTRICAL STACKS (.1) Item 3(Picture)

Boots for plumbing, vents, electrical stacks and flues should have shingles that are lapped over boot on top and sides. Sides are not lapped. Recommend having roofing expert seal the sides of boot.

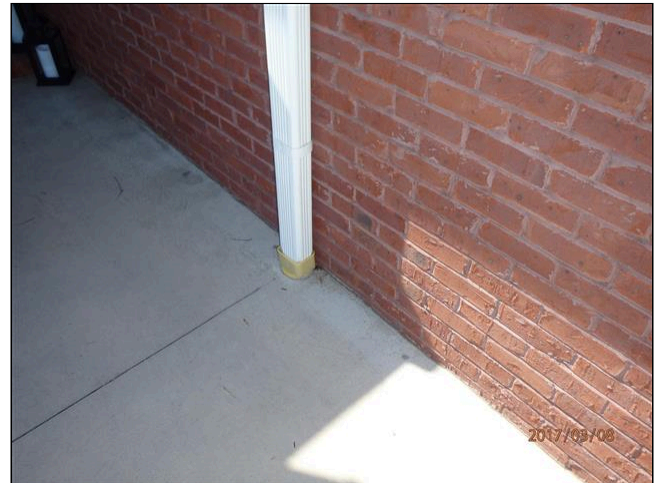
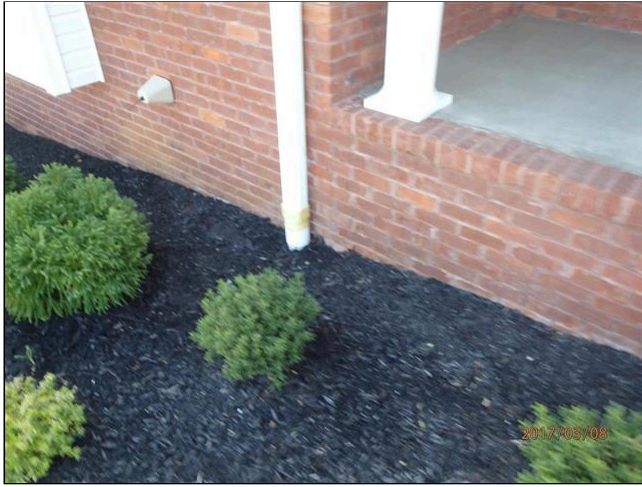
1.5 DOWNSPOUTS / ROOF DRAINS (.1) Item 1(Picture)

1.5 DOWNSPOUTS / ROOF DRAINS (.1) Item
2(Picture)

Downspouts that run into the ground are subject to backup/blockage. Neither the presence nor integrity of underground lines, nor free flow of water through such lines is determinable as part of this inspection. I would recommend finding the end of these drain lines to make sure they are not clogged.

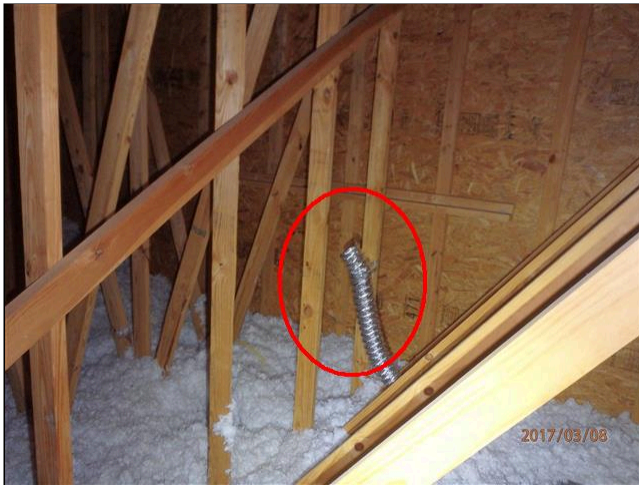
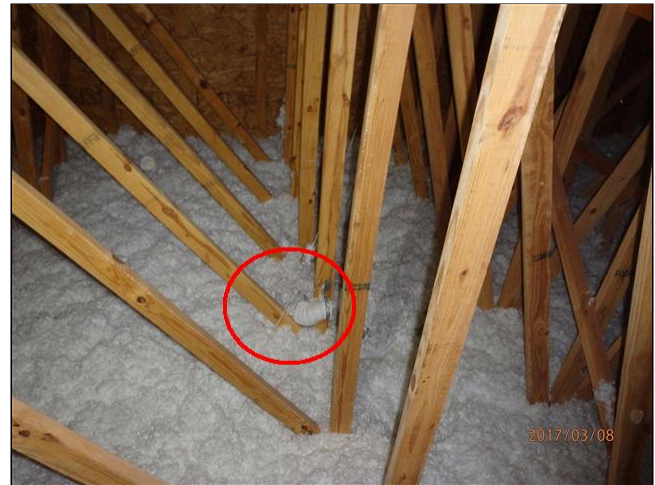
2.4 VENTILATOR DISCHARGE (.1) Item 1(Picture)

2.4 VENTILATOR DISCHARGE (.1) Item 2(Picture)

Bathroom ventilators discharge into the attic. This puts more moisture into an attic and may cause mold to grow. Recommend having ventilator discharge to outside.
