165 Verde Valley School Rd
Unit 37
Sedona AZ 86351

3/14/2017

HouseMaster Phoenix

Single Family, Condominium

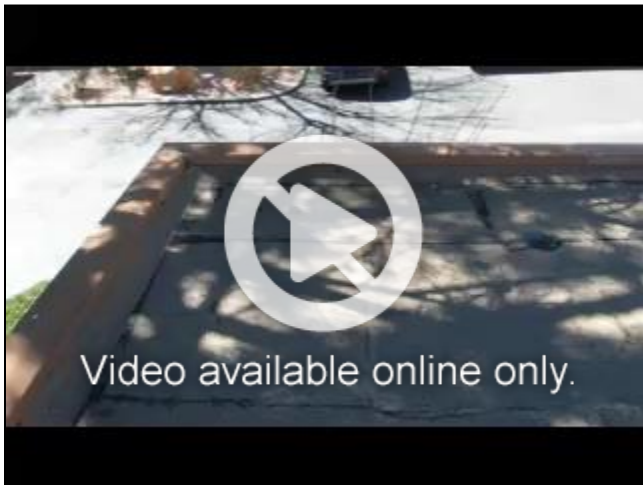
1.0 ROOF COVERING 1 (Video 1)

●					1.0 ROOF COVERING 1 Normal wear .
●					1.1 EXPOSED FLASHING Keep caulked and flashed.
●					1.2 PLUMBING STACKS
●					1.3 VENTILATION COVERS
			●		1.4 SKYLIGHT(S)
			●		1.5 RAIN GUTTERS / EAVESTROUGHS
			●		1.6 DOWNSPOUTS / ROOF DRAINS
●					1.7 FASCIA / SOFFITS Weather worn.
			●		1.8 CHIMNEY

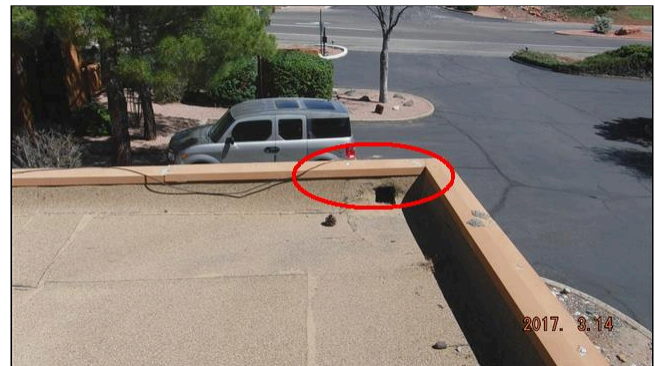
1.0 ROOF COVERING 1 (Picture 2) Roof Drain

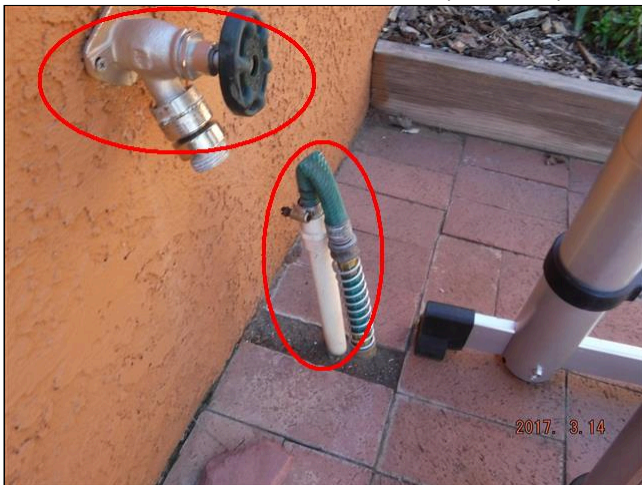
2.8 EXTERIOR FAUCET(S) (Picture 1) Possible landscape water hose

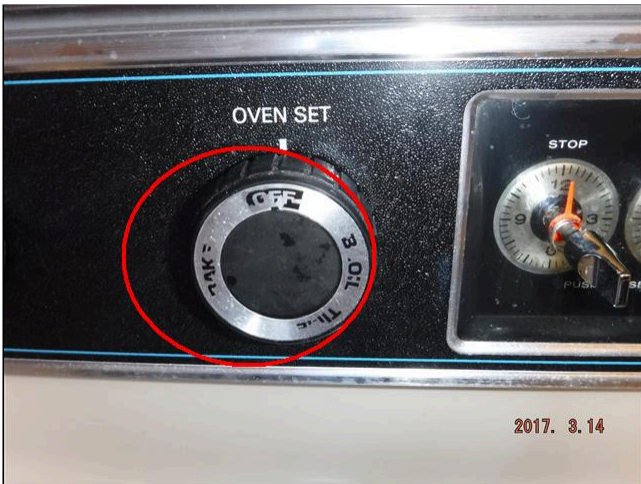
7.4 RANGE (Picture 2) Worn controls
