165 Verde Valley School Rd
Unit 37
Sedona AZ 86351

3/14/2017

HouseMaster Phoenix

INSPECTION INFORMATION**CLIENT:***Linda Baron***PROPERTY ADDRESS:***165 Verde Valley School Rd
Unit 37
Sedona AZ 86351***INSPECTION DATE/TIME:***3/14/2017 - 12:00 pm***INSPECTOR:***Hal Kunnen***INSPECTION COMPANY:***HouseMaster Phoenix
3030 S Rural Rd, STE 109
Tempe AZ 85282
480-345-8570
HouseMaster.com***INSPECTION DETAILS****AGE OF HOME/BUILDING:***32 years***DESCRIPTION:***Single Family, Condominium***TYPE OF INSPECTION:***Standard Home Inspection***PEOPLE PRESENT:***Sapp***STATUS OF HOME:***Vacant***ANCILLARY SERVICES:***Wood-Destroying Insect***WEATHER:***Sunny***TEMPERATURE:***65 F***AUTHORIZED DISTRIBUTION:***Client and Client's Agent***BTR INSPECTOR LICENSE:***#38065***INTRODUCTION**

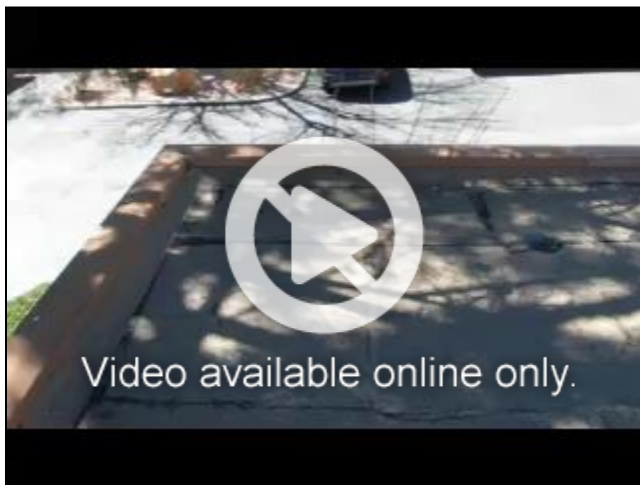
1.0 ROOF COVERING 1 (Video 1)

●						1.0 ROOF COVERING 1 Normal wear .
●						1.1 EXPOSED FLASHING Keep caulked and flashed.
●						1.2 PLUMBING STACKS
●						1.3 VENTILATION COVERS
			●			1.4 SKYLIGHT(S)
			●			1.5 RAIN GUTTERS / EAVESTROUGHS
			●			1.6 DOWNSPOUTS / ROOF DRAINS
●						1.7 FASCIA / SOFFITS Weather worn.
			●			1.8 CHIMNEY

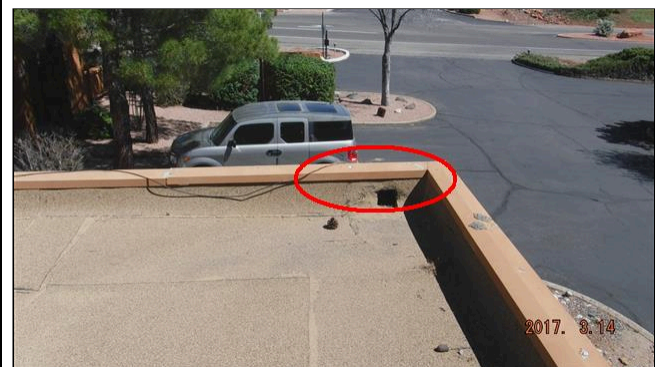
1.0 ROOF COVERING 1 (Picture 2) Roof Drain

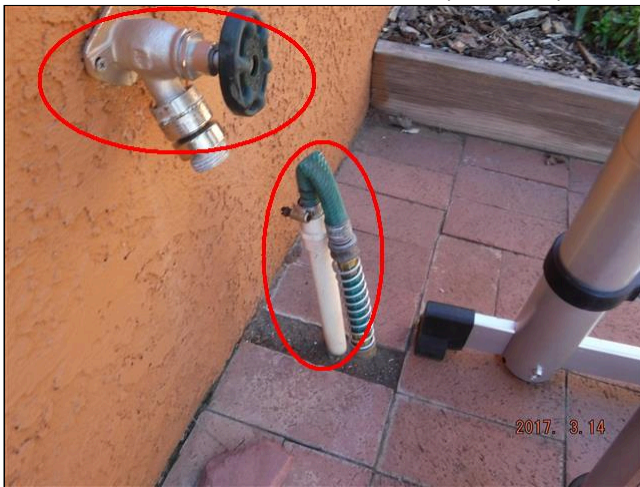
2.8 EXTERIOR FAUCET(S) (Picture 1) Possible landscape water hose

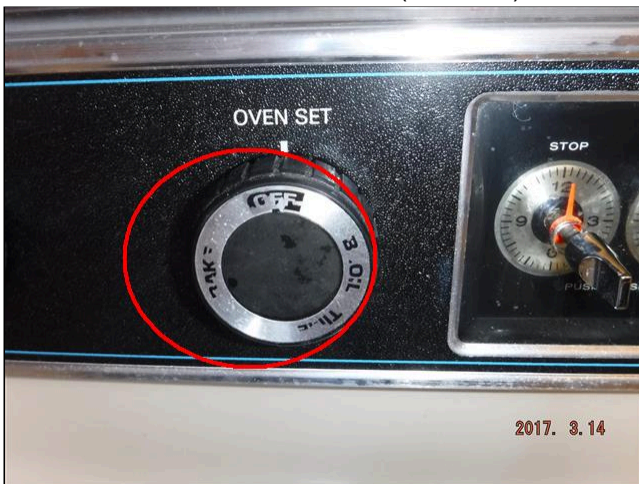
7.4 RANGE (Picture 2) Worn controls

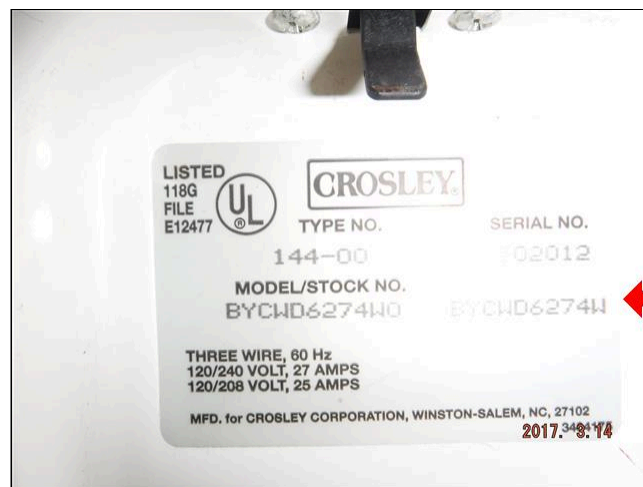
13.5 LAUNDRY AREA AND VENT FAN and dryer vent (Picture 2) Washer dryer
